# SAMPLE — Synthetic construction appendix

Week 2026-09-07 to 2026-09-13

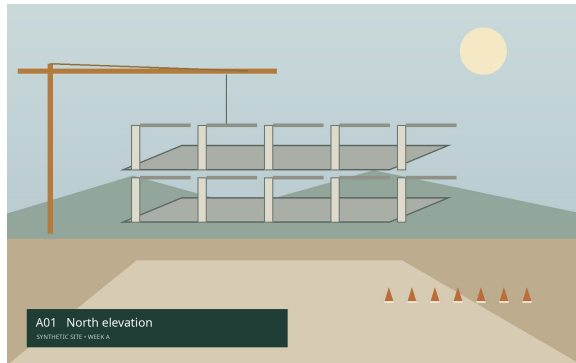
Photo 01

North elevation: concrete columns and level-one formwork in place. Confirm the open bays before next week.

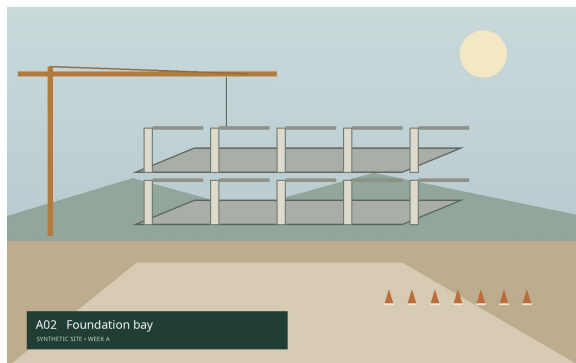
Photo 02

Fundação — seção norte. Reinforcement layout visible; concrete placement to be reviewed.

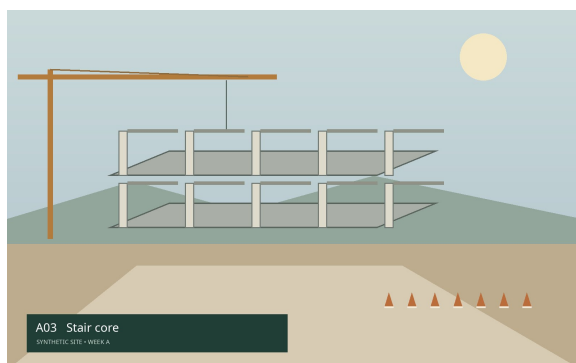
Photo 03

Stair core: lower flight and landing reference. Maintain this view for the weekly comparison.

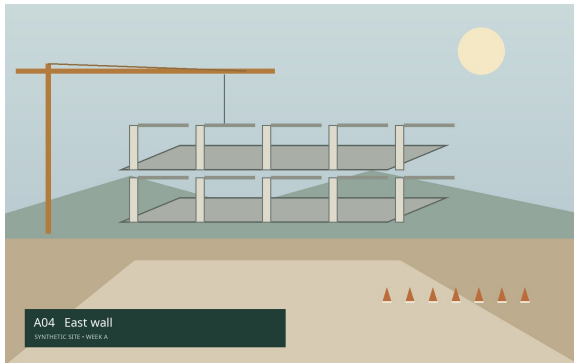
Photo 04

East wall: masonry sample panel and perimeter access.

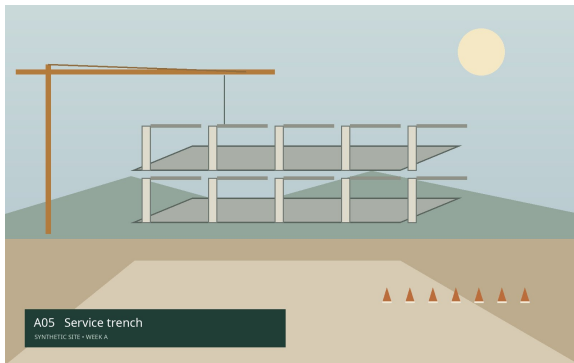
Photo 05

Service trench: alignment reference along the east boundary.

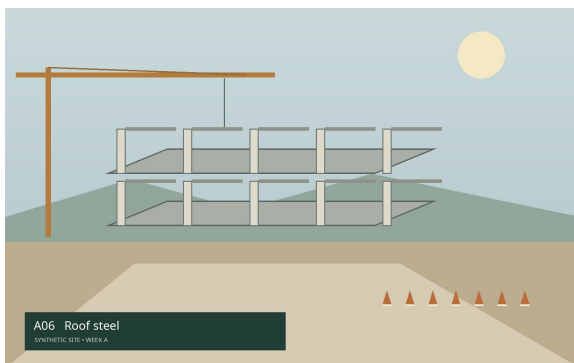
Photo 06

Roof steel: primary beam connections viewed from ground level.

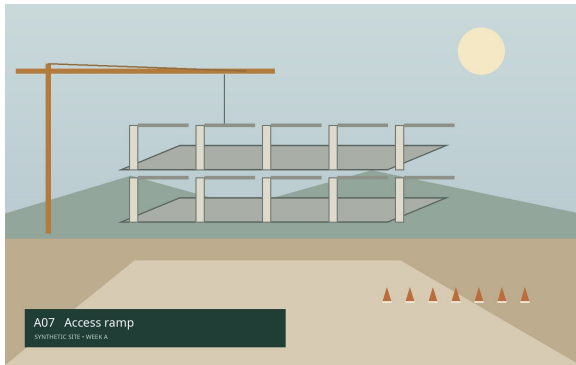
Photo 07

Access ramp: temporary edge protection and approach.

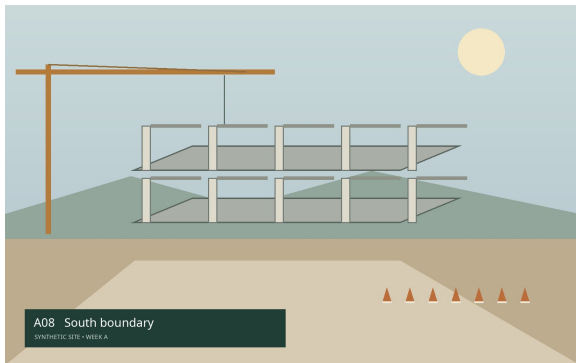
Photo 08

South boundary: site access and perimeter reference.
