# SAMPLE — Synthetic construction appendix

Week 2026-09-14 to 2026-09-20

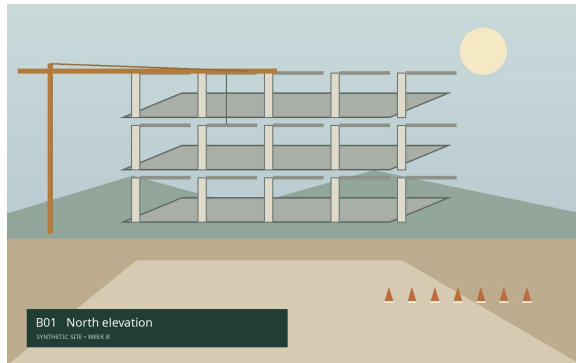
Photo 01

North elevation: concrete columns and level-one formwork in place. Confirm the open bays before next week.

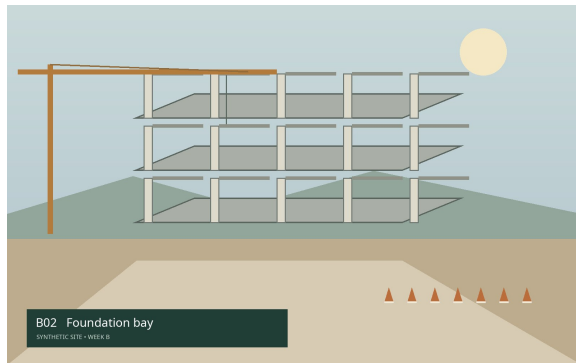
Photo 02

Fundação — seção norte. Reinforcement layout visible; concrete placement to be reviewed.

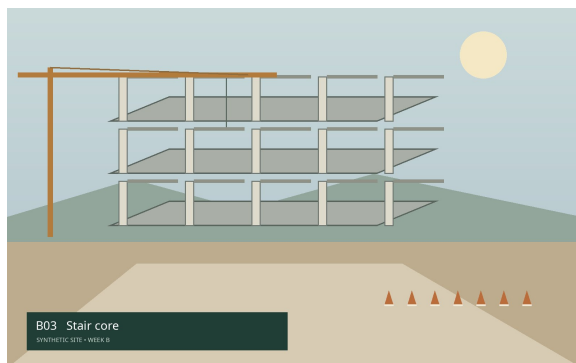
Photo 03

Stair core: lower flight and landing reference. Maintain this view for the weekly comparison.

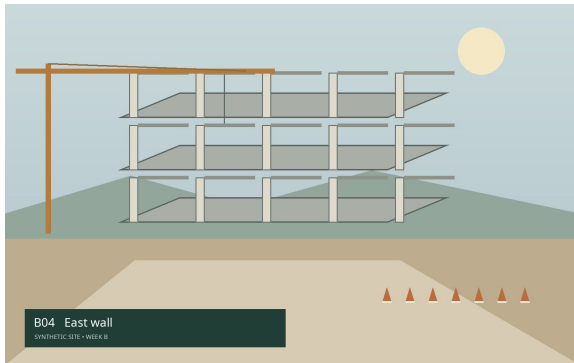
Photo 04

East wall: masonry sample panel and perimeter access.

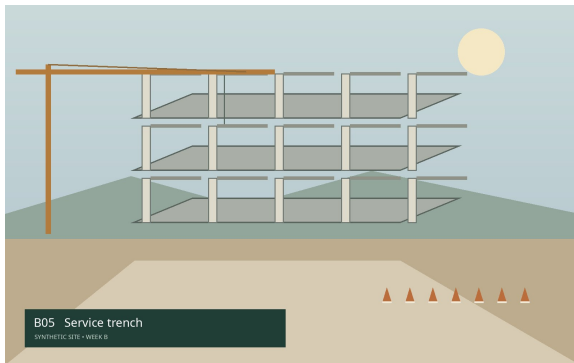
Photo 05

Service trench: alignment reference along the east boundary.

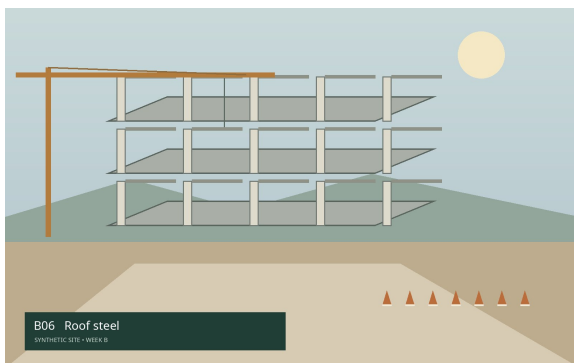
Photo 06

Roof steel: primary beam connections viewed from ground level.

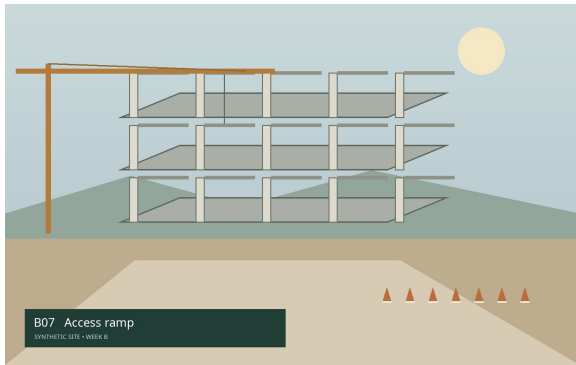
Photo 07

Access ramp: temporary edge protection and approach.

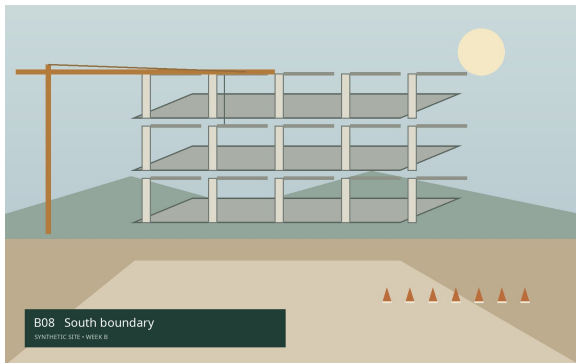
Photo 08

South boundary: site access and perimeter reference.
